Description of Keuka Outlet

Keuka Outlet Water Quality by Location, 2014 - 2018

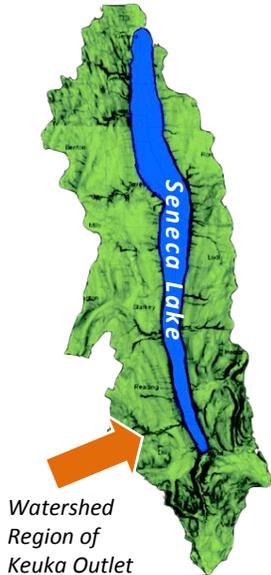
SPWA Water Sampling Locations

SLPWA has sampled the outlet since 2015, beginning with four locations from the discharge of Keuka Lake to Dresden, near the mouth at Seneca Lake. Two sampling locations were added in 2016, and another in 2018—one at the confluence of Jacobs Brook in Penn Yan at the Birkett Mills plant site, one at the discharge outfall of the Penn Yan Wastewater Treatment Plant (WWTP), and finally at the Indian Pines Park. Sampling is typically performed 4-5 times per year at these locations, spring through fall.
